# Restoration of a Zenith Transoceanic Clipper model 8G005 By Doug Crompton, WA3DSP

**This photo shows the restored and operational radio. Below I take you through the process of electrical and mechanical restoration.**

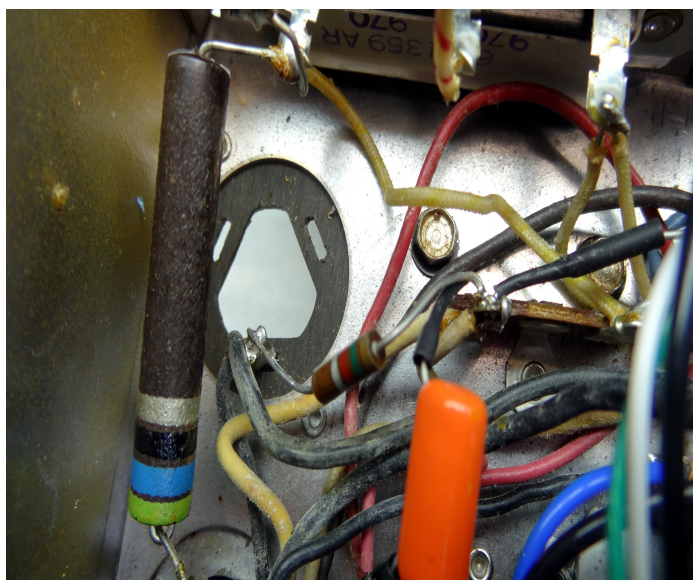
**40/20/10uf Electrolytic removed**

Closeups of the two electrolytic cans removed. In one case I actually cut the can out which was unnecessary. I never re-stuff cans, it is a waste of time. On the second one I remove all the wires, twisted off the three retainer tabs and removed the old can. The phenolic mounting plate is left as shown above.

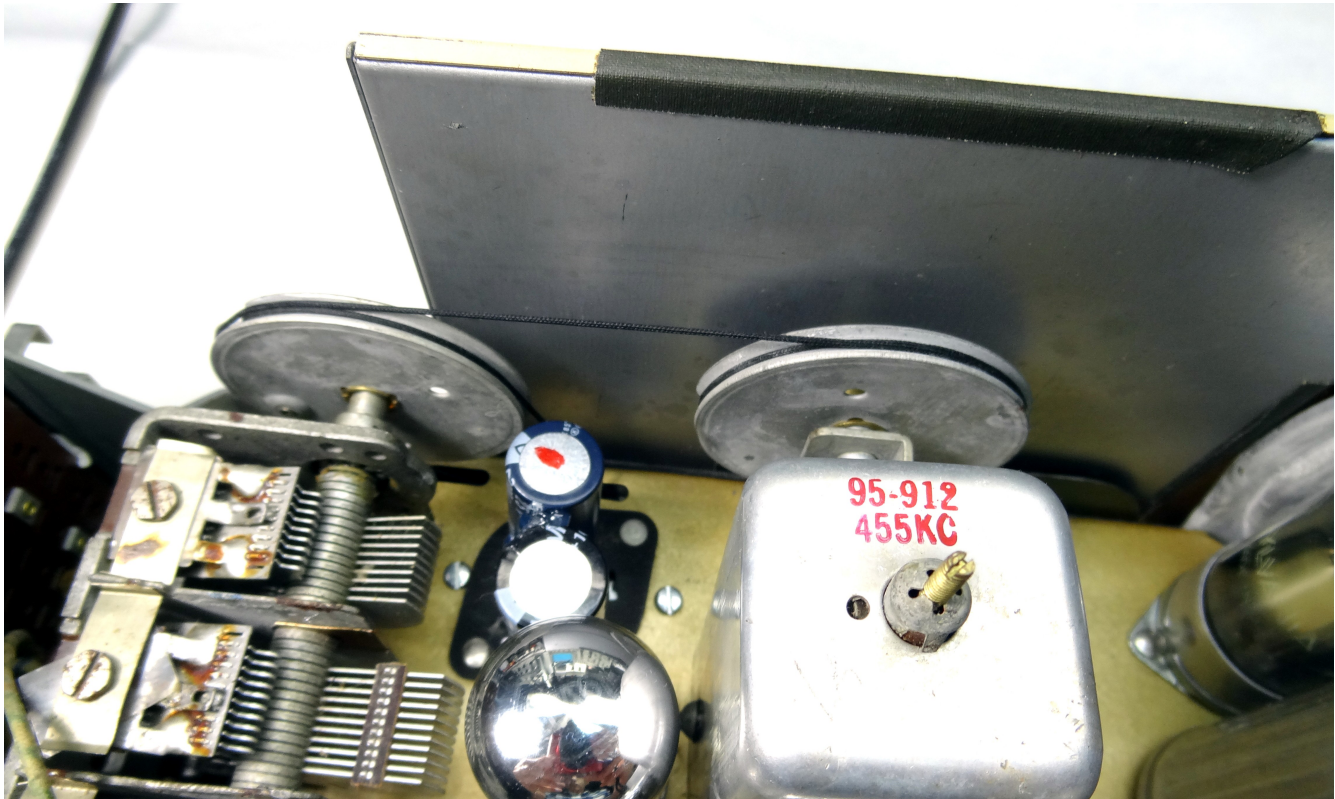
And the new cord installed. The cord I used was heavier than what is often used and because of that I used an extra turn around the tuning shaft below the chassis. The final result was a solid non-slip feel when tuning. The spring and cord are pulled very tight.

**New dial cords installed. This radio uses two runs and two springs. One between the tuning shaft and the capacitor shaft and one between the capacitor shaft and the dial shaft.**

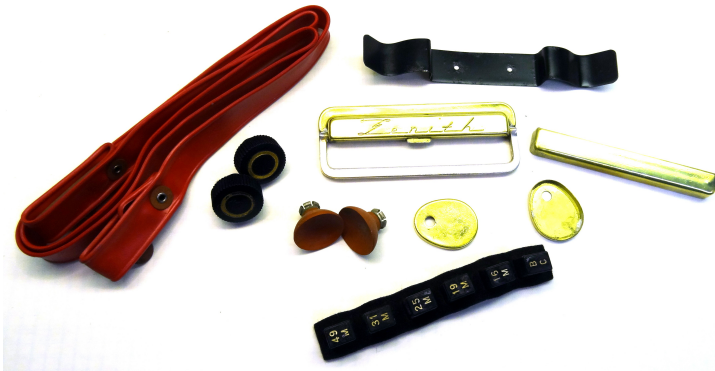
Some of the items removed and cleaned, painted and polished. Not shown are the screws which were also painted.

Parts removed were thoroughly cleaned, rust removed, and polished or painted as required. Once the case covering was repaired the black leather dye was applied. You do need to mask areas you do not want painted. The dye will stain anything including your hands so be sure to wear gloves.

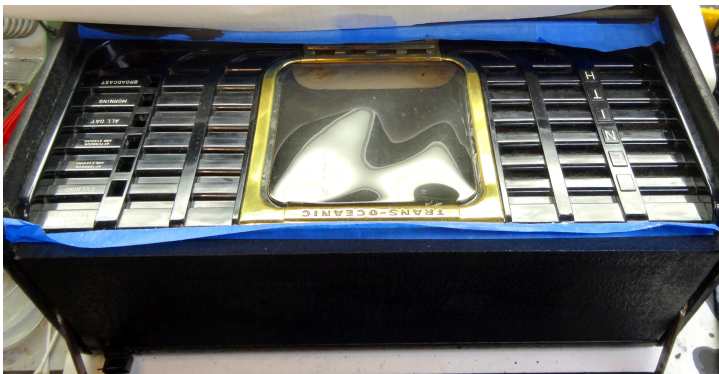
Carefully mask areas you do not want painted with the black leather dye. Cover the entire dial area also to avoid accidents.

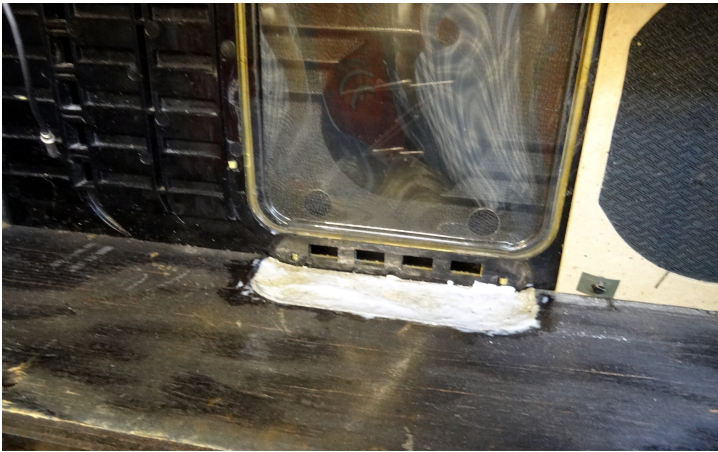
I am not sure what it was but the material under the chassis front panel switches sure looked to me like asbestos. Why it needed to be there I don't know as there is no special need such as higher heat at that location. I decided to be cautious and cover it with a liberal coat of Elmers glue to seal it in place.

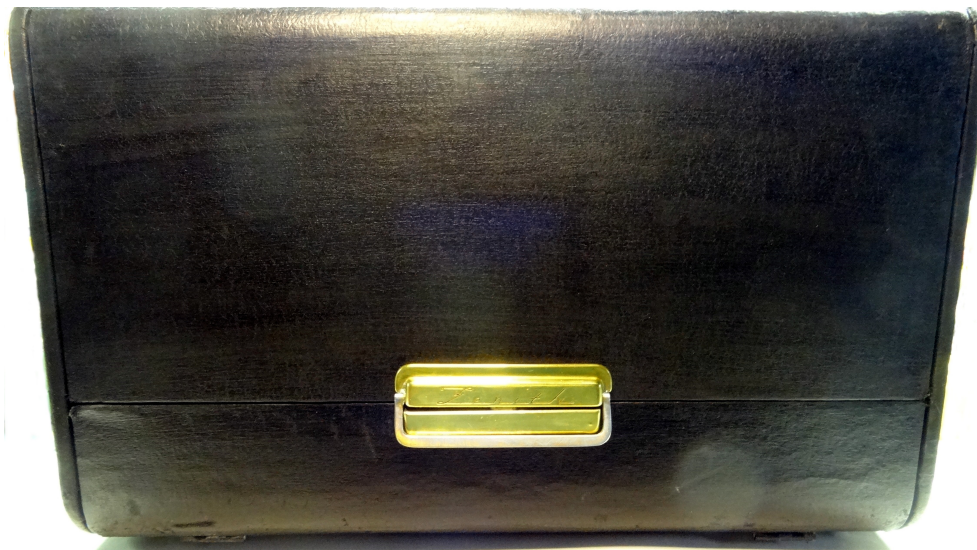
Front after dyeing and reinstalling hardware.

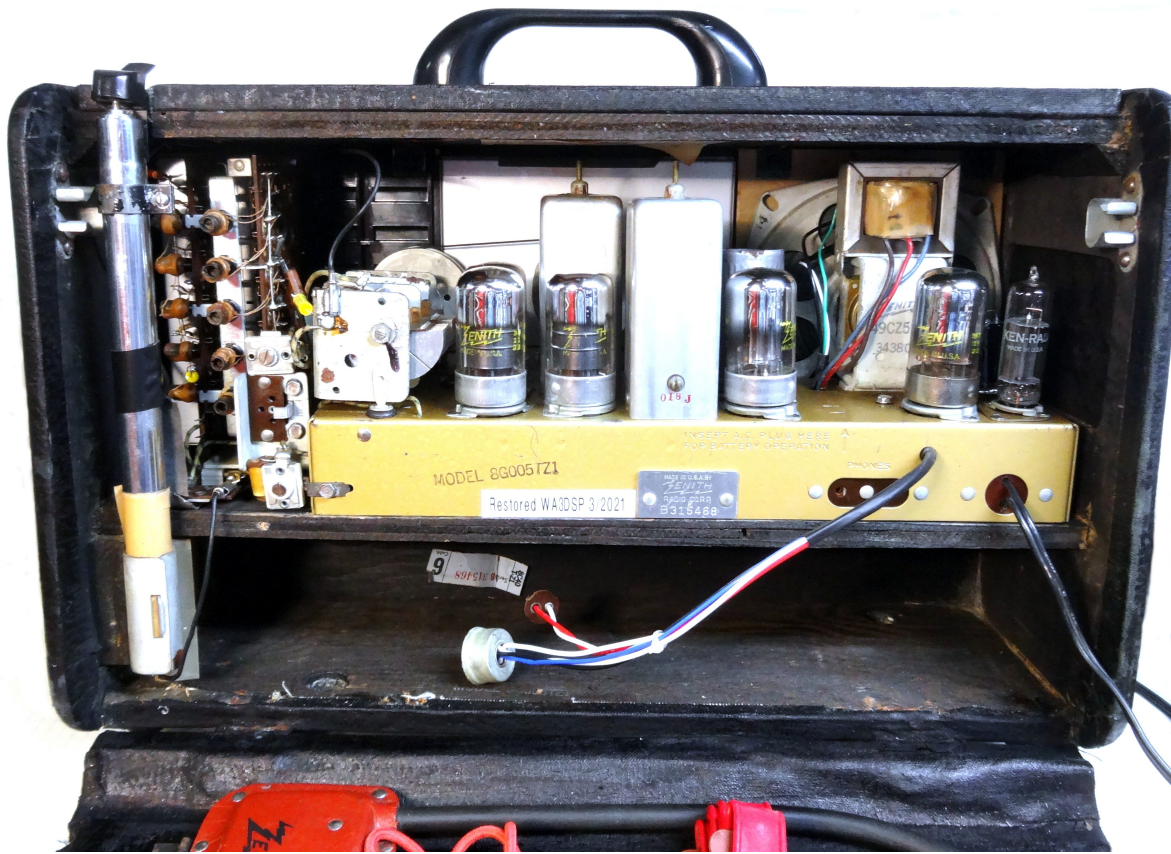
**Chassis re-installed in the cabinet**

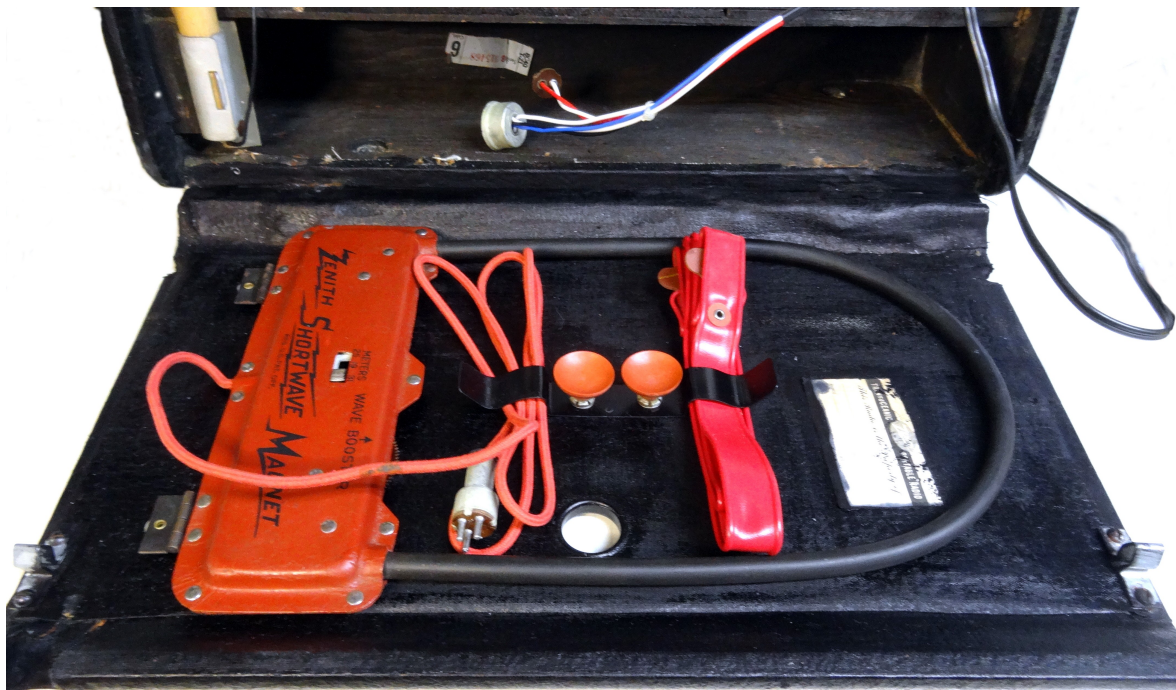
**Finished rear panel showing accessories**

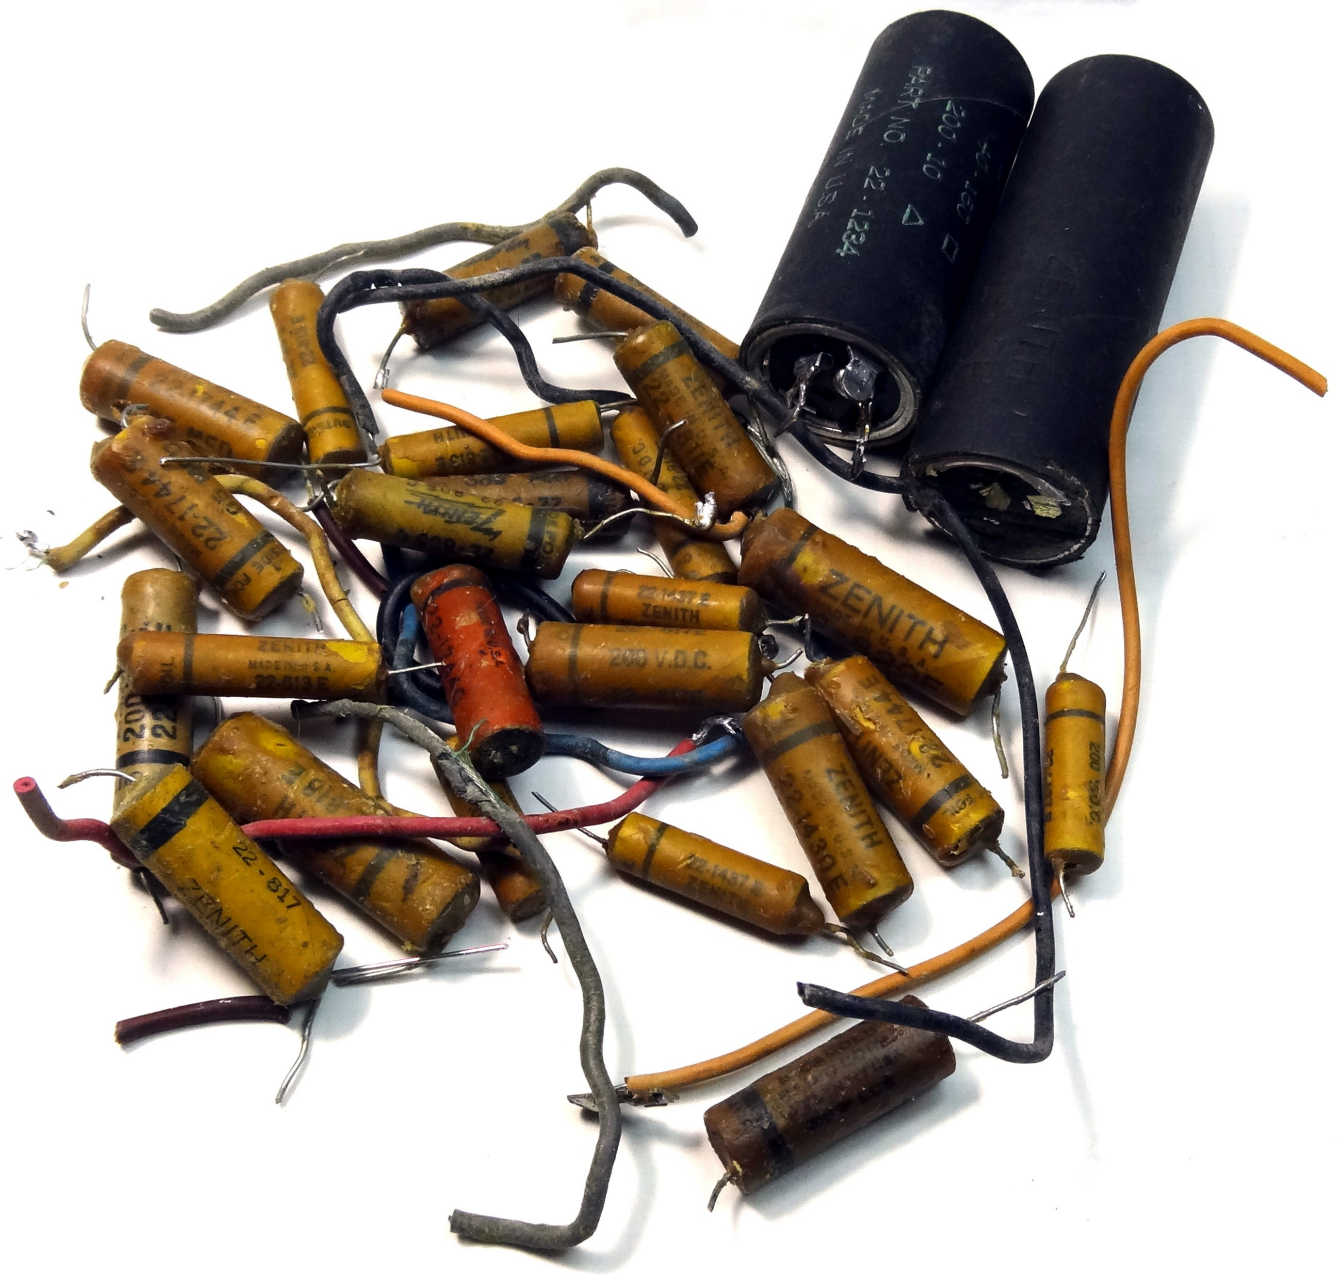
**And here it is, the pile of parts removed and replaced!**
